Seattle Post-COVID Recovery Plan

Lyle Bicknell Client, City of Seattle
David Blum Affiliate Instructor

Overview

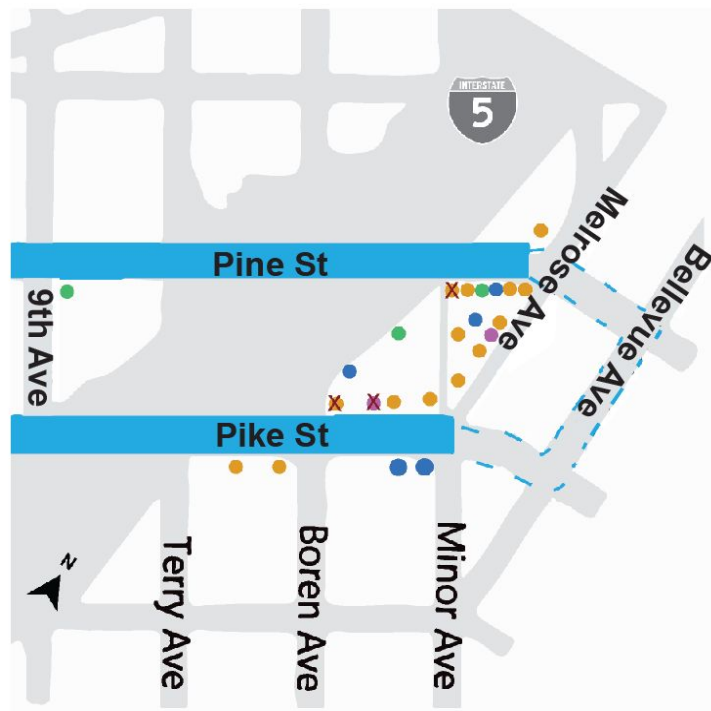
Pike-Pine Corridor Asset Mapping: 9th Ave to Melrose Ave

Retail-

Food/Drink-

Medical/Professional-

Recreation/Entertainment-

Temporarily Closed-

Permanently Closed-

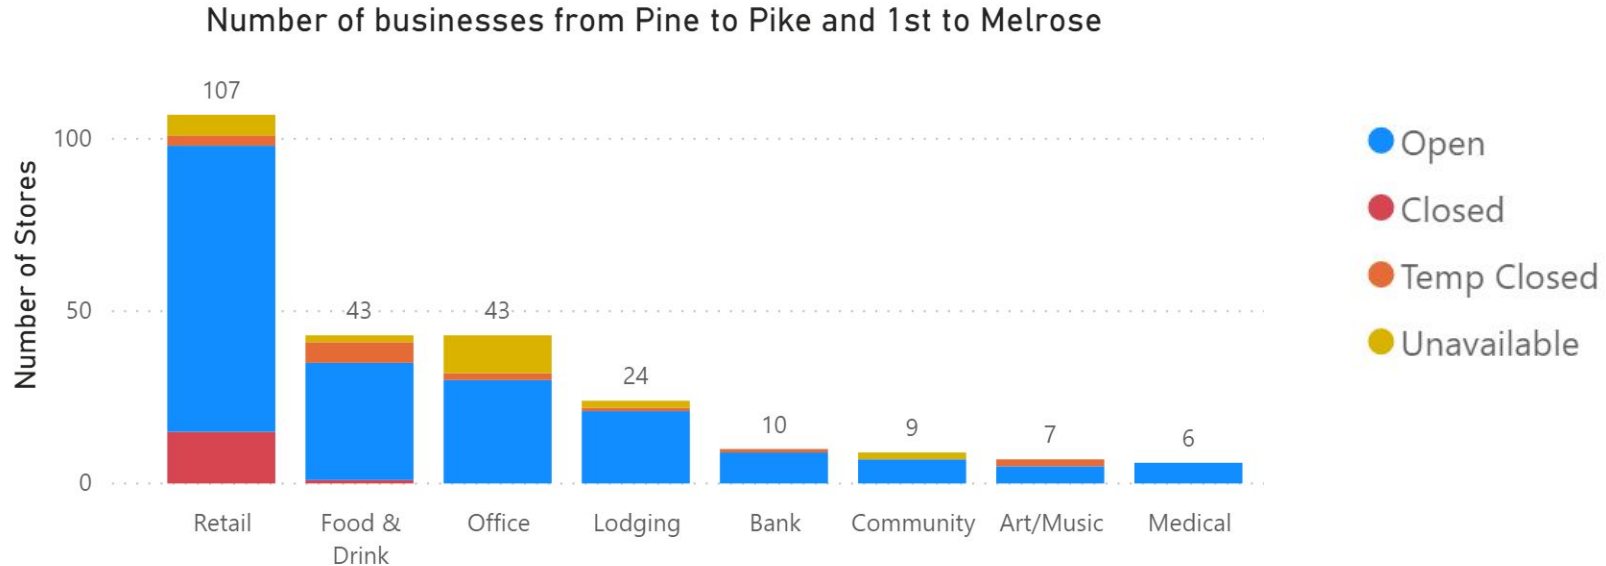
Pike-Pine Corridor: Sector Performance

- There is a higher percentage of permanently closed stores in the retail sector.
- There are more temporarily closed stores in the food & drink sectors.

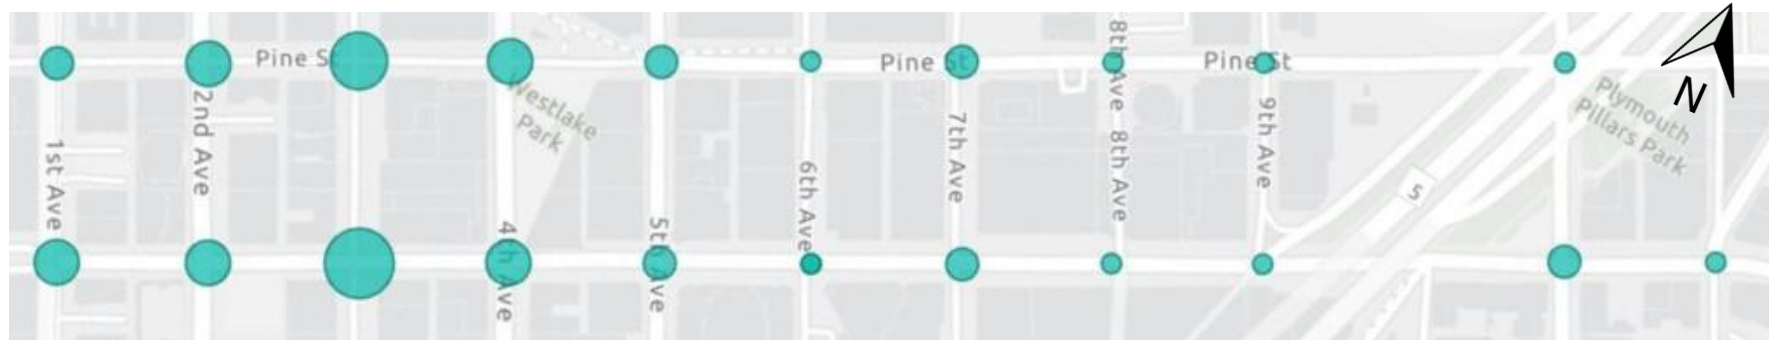
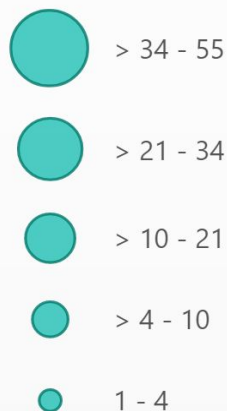
Pike Pine Corridor: Location of Criminal Incidents in 2020

Highest occurrence along 3rd Ave (Pine and Pike)
followed by 1st Ave & Pike St

The leading offenses are simple assault and theft
from motor vehicles

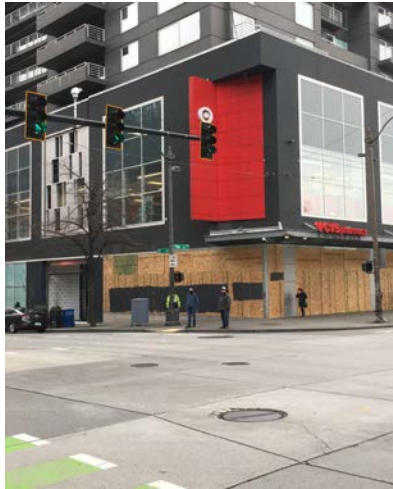
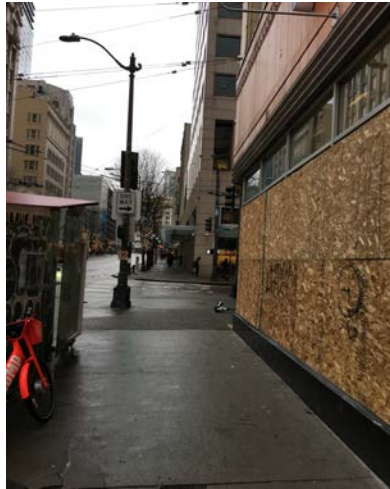
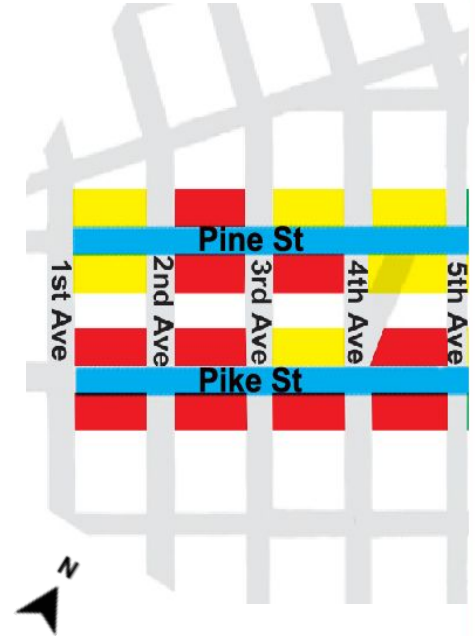
1st Ave to 5th Ave

- These blocks are in poor condition.
- The main issues with this area are
 - There is a high percentage of storefronts that are boarded.
 - There is a high amount of Inappropriate use of public space.
 - The area does not feel safe.
- These issues seem to be most concentrated South of Pike St.

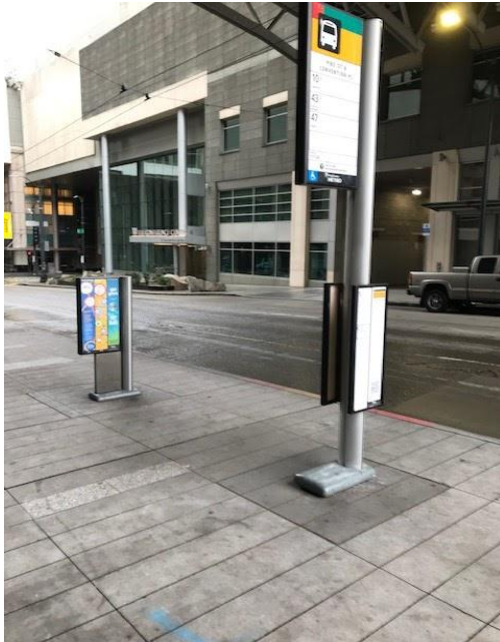
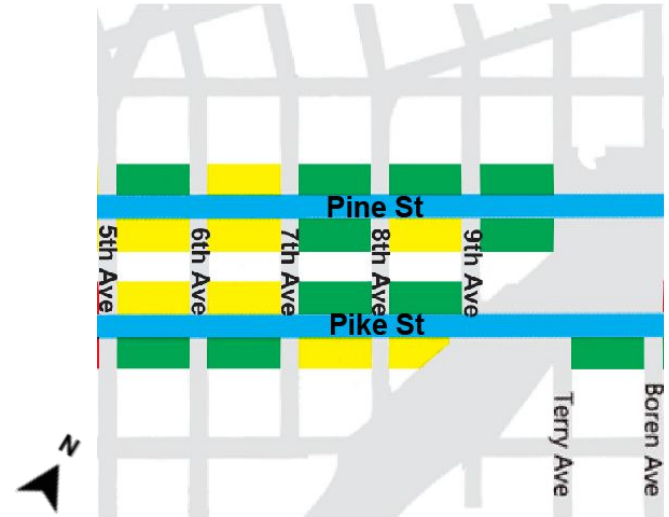
5th Ave to Boren Ave

- These blocks are in good condition.
- It seems the Convention Center is keeping the area clean.
- The only issue is there are a few storefronts that are boarded.

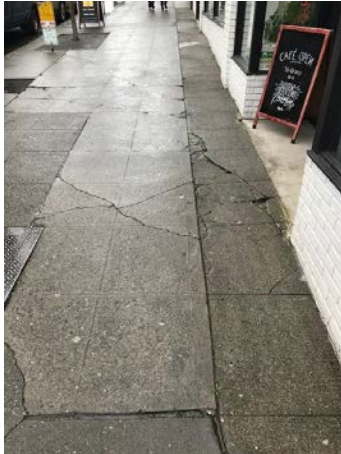
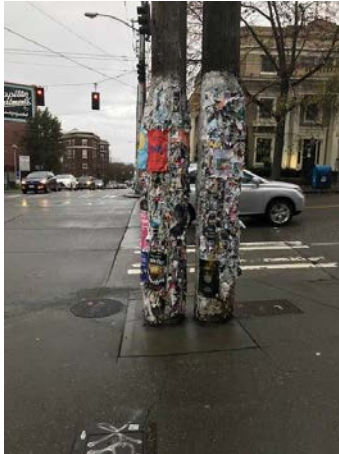
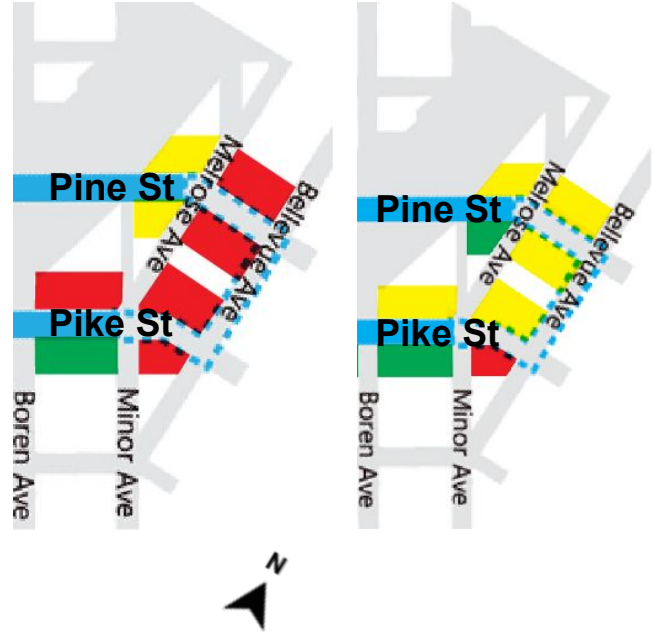
Boren Ave to Bellevue Ave

- These blocks are in fair/poor condition.
- The main issues with this area are:
 - The sidewalk is in poor condition.
 - There is some inappropriate use of public space.
 - There are a lot of posters on all of the light poles.
 - They are peeling off and it looks bad.
 - If this is not a pressing issue then use the right map.
